Subject: 3-4 SHIFT SHOCK	Bulletin No: 05-010/10
	Last Issued: 08/06/2010

APPLICABLE MODEL(S)/VINS

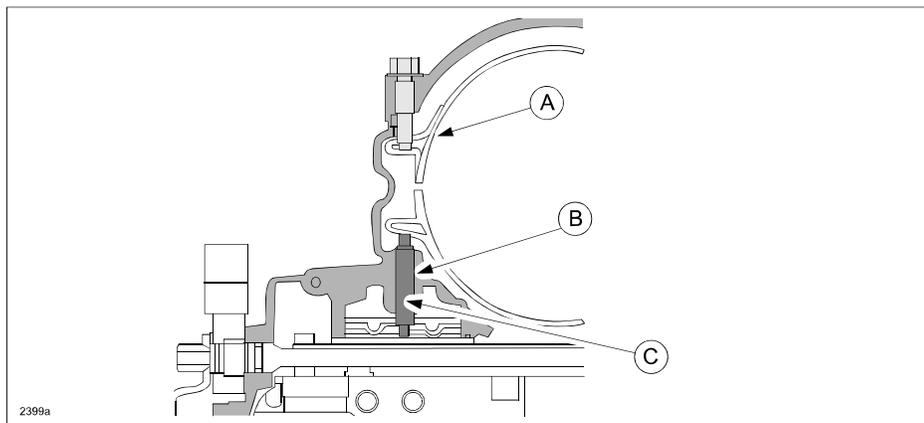
Some vehicles may experience an excessive 3-4 shift shock when driving on an uphill road or with some load applied. Due to uneven wear on the servo piston bore (B), oil leakage from the bore occurs. This in turn causes a mistimed engagement of the 2/4 band (A), resulting in the 3-4 shift shock. To correct the problem, the servo piston (C) hardness has now been changed.

1. Verify customer concern.
2. Follow the "Diagnosis Flowchart" and if the concern seems to be due to wear on the servo piston bore, replace the transmission.
